CASE STUDY

Surgical Repair of a Subluxed Tibia/Fibula Fracture Utilizing Low-Profile Locking Plate

CoLink° **Afx** Lateral Fibula Plate

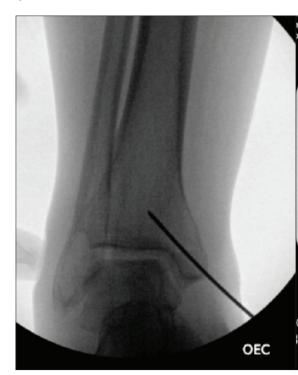
Figure 3

Utilizing the C-arm, a guide pin was placed across the fracture site from the medial malleolus into the body of the tibia. Care was taken to not penetrate the lateral cortex of the tibia in order to give a more accurate measurement for

the screw. (**Figure 3**) The pin was measured and the hole was drilled and countersunk. A small stab incision was made in order to place the screw. The screw was selected, inserted and tightened. (**Figure 4**)

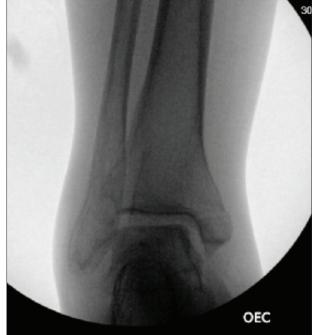
Figure 1. Pre-op X-ray

X-rays were taken of the foot and the ankle. Immediately noted was the tremendous damage to the integrity of the ankle joint. At the time of her fall, she sustained a fracture to the fibula, the tibia, and subluxation of the ankle joint. Also, there likely was a complete disruption to the ligamentous structures as well, including the syndesmotic ligament. (**Figure 1**)

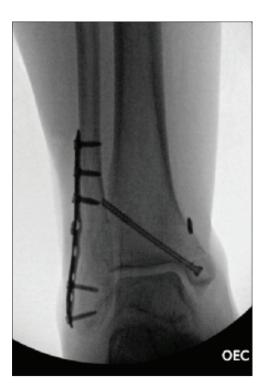
Figure 6: Post-op X-ray

A final image was taken to ensure that the fractures had adequately been reduced, and stabilized. Once that was determined, the incisions were closed. (**Figure 6**) Local anesthesia, stem cells, and PRP was injected. The ankle was bandaged and the tourniquet was released. A large dressing was applied. A short leg, cast was applied and the patient was transferred to the recovery room for monitoring.
