CASE STUDY

Tibial Plafond Fracture Repair with CoLink[®] Afx

Author: Calvin J. Rushing, DPM, AACFAS Dallas, TX

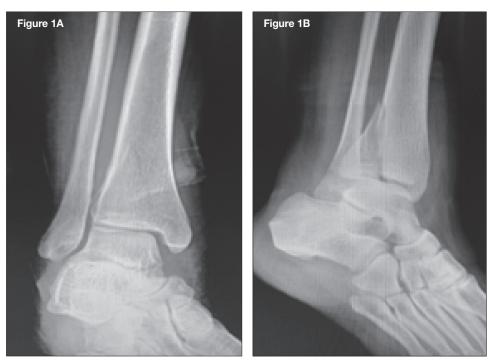
Figure 1. Initial non-weight-bearing X-rays. (A) AP. (B) Lateral.

Conventional non-weight-bearing radiographs obtained from the hospital revealed a displaced tibial plafond fracture with possible involvement of the distal tibiofibular syndesmosis or deltoid ligament (**Figure 1A-B**).
